# VOLUNTARY RECALL CAMPAIGN

Classification: BT24-004	Reference: NTB24-042	Date: August 6, 2024
-----------------------------	-------------------------	-------------------------

## VOLUNTARY SAFETY RECALL CAMPAIGN 2024 FRONTIER; FRONT RH COMBINATION LAMP

**CAMPAIGN ID #:** PD121  
**APPLIED VEHICLES:** 2024 Frontier (D41)

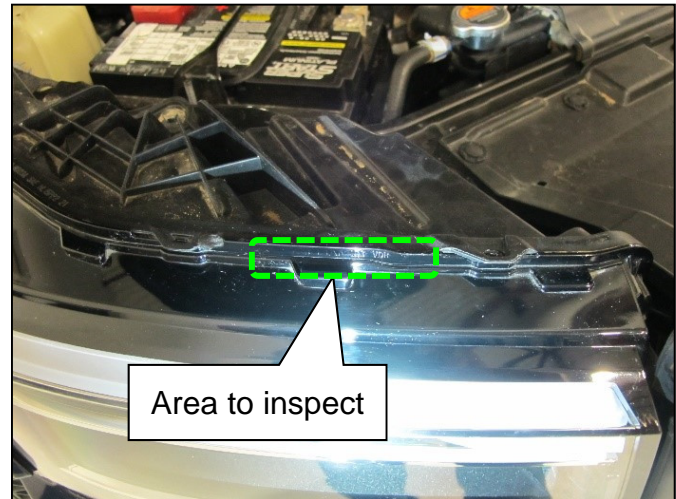
Figure 3

3. Locate the inspection area on the top of the front passenger (RH) combination lamp.
  - The inspection area is outlined in GREEN in Figure 3.

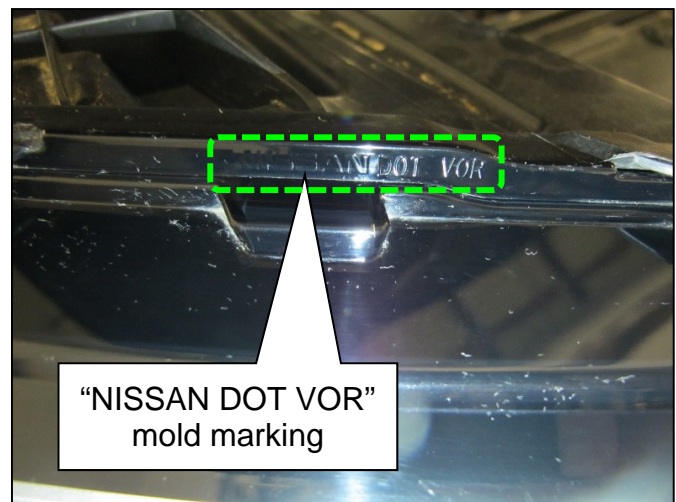
Figure 4

4. Visually locate the “NISSAN DOT VOR” mold marking (Figure 4).

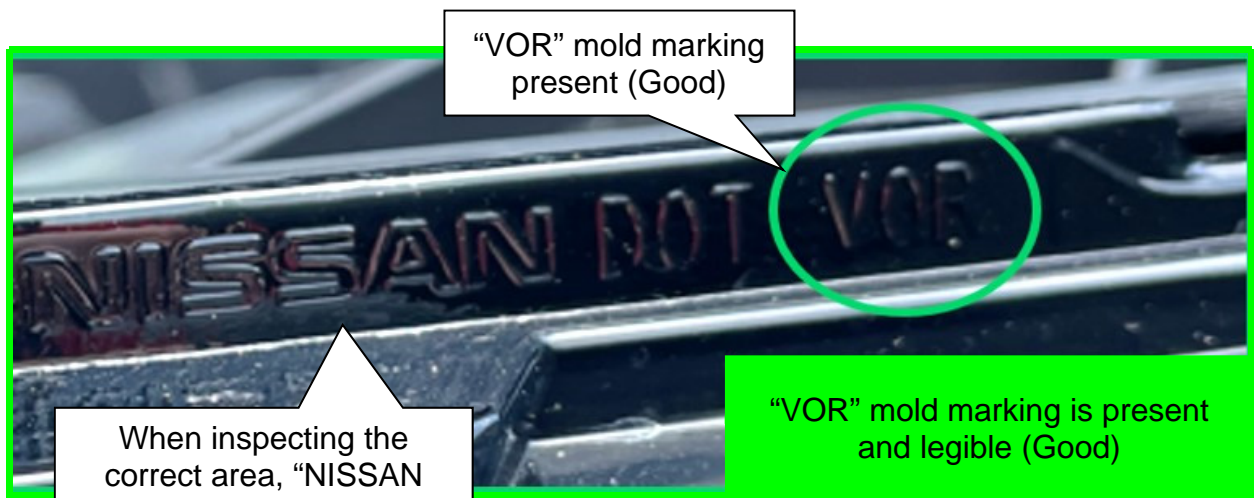
5. Is the “VOR” mold marking present AND legible on the front passenger (RH) combination lamp, as shown in Figure 5?

**YES:** The “VOR” mold marking is present AND is legible on the front passenger (RH) combination lamp, as shown in Figure 5. Front passenger (RH) combination lamp replacement is NOT required. Skip to step 10 on page 6.

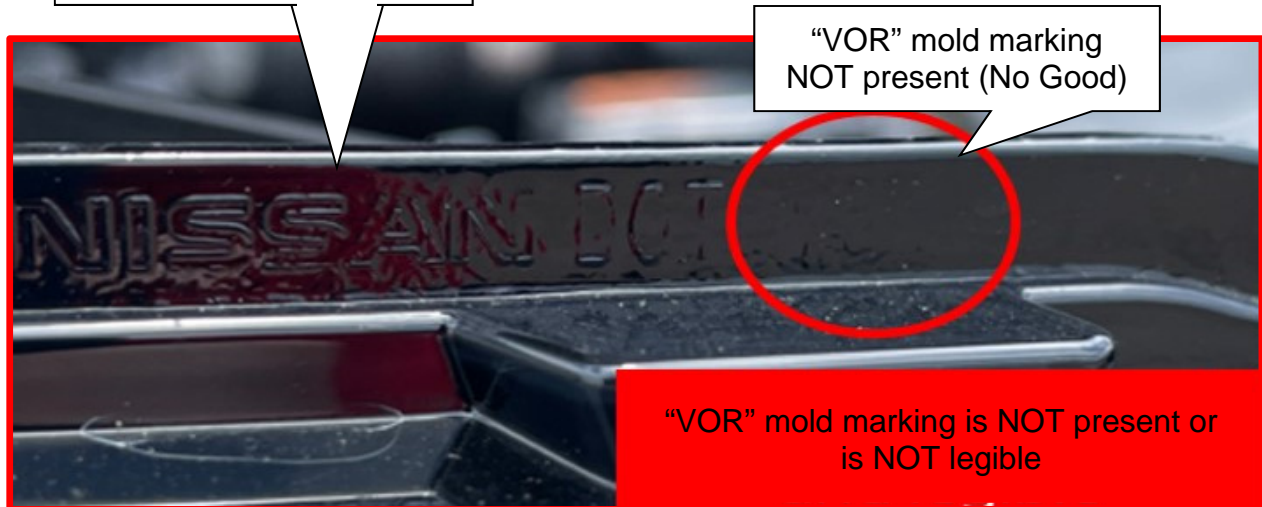
**NO:** The “VOR” mold marking is NOT present or is NOT legible on the front passenger (RH) combination lamp, as shown in Figure 6. Continue to step 6 on page 5 to replace the front passenger (RH) combination lamp.

6. Replace the front passenger (RH) combination lamp.
  - Refer to the ESM: **DRIVER CONTROLS > EXTERIOR LIGHTING SYSTEM > REMOVAL AND INSTALLATION > FRONT COMBINATION LAMP > Removal and Installation**
    - Tighten the front passenger (RH) combination lamp bolts to 5.0 N•m (0.51 kg-m, **44 in-lb**)
