# VOLUNTARY RECALL CAMPAIGN

Classification: BT24-004	Reference: NTB24-042	Date: August 6, 2024
-----------------------------	-------------------------	-------------------------

## VOLUNTARY SAFETY RECALL CAMPAIGN 2024 FRONTIER; FRONT RH COMBINATION LAMP

**CAMPAIGN ID #:** PD121  
**APPLIED VEHICLES:** 2024 Frontier (D41)

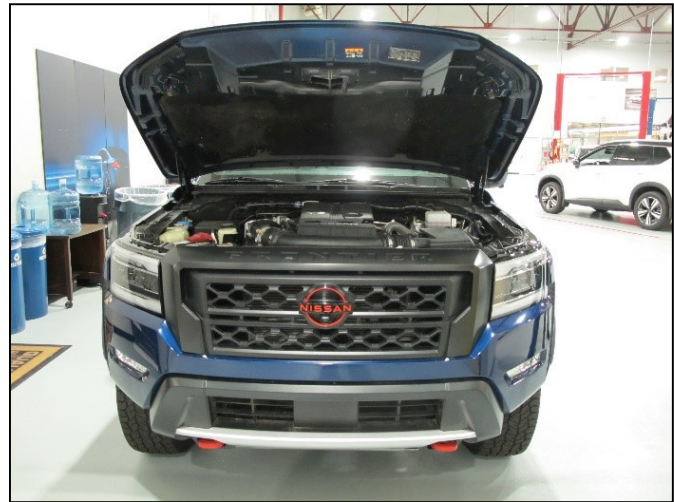
Figure 1

1. Open the hood.

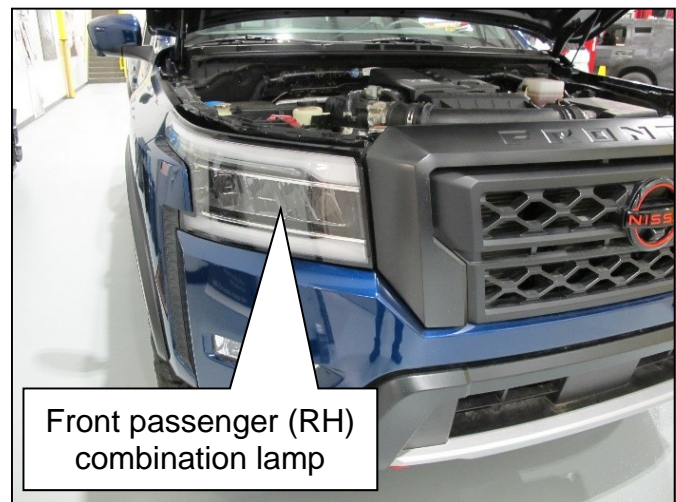
2. Locate the front passenger (RH) combination lamp.

**HINT:** The combination lamp shown in Figure 2 is an LED combination lamp. A Halogen combination lamp is similar.

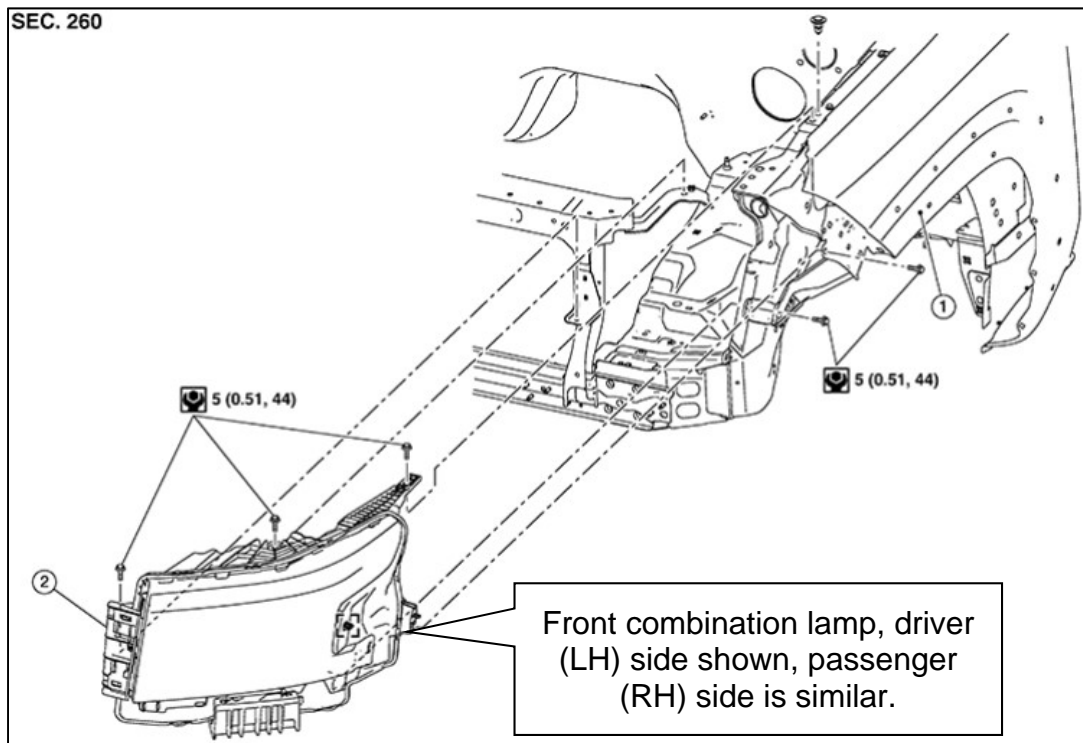
Figure 7

**HINT:** The front driver (LH) combination lamp is shown in Figure 7, the front passenger (RH) combination lamp is similar.

6. Replace the front passenger (RH) combination lamp.
  - Refer to the ESM: **DRIVER CONTROLS > EXTERIOR LIGHTING SYSTEM > REMOVAL AND INSTALLATION > FRONT COMBINATION LAMP > Removal and Installation**
    - Tighten the front passenger (RH) combination lamp bolts to 5.0 N•m (0.51 kg-m, **44 in-lb**)

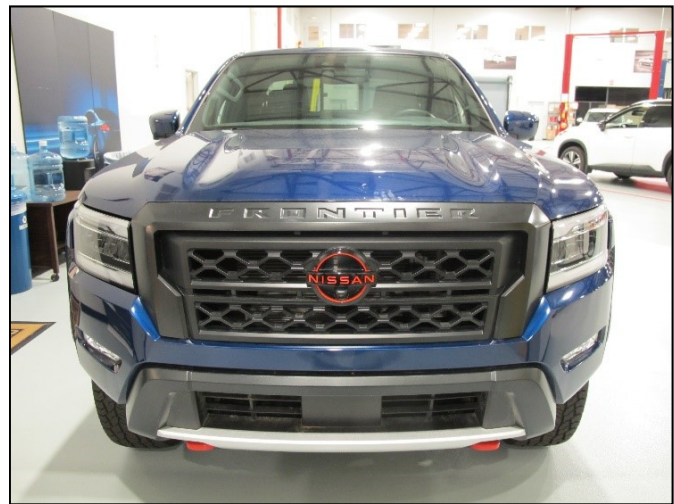
Figure 8

10. Close the hood.
